Semi Submersible “WHITTINGTON”

Marine Casualty Final Report

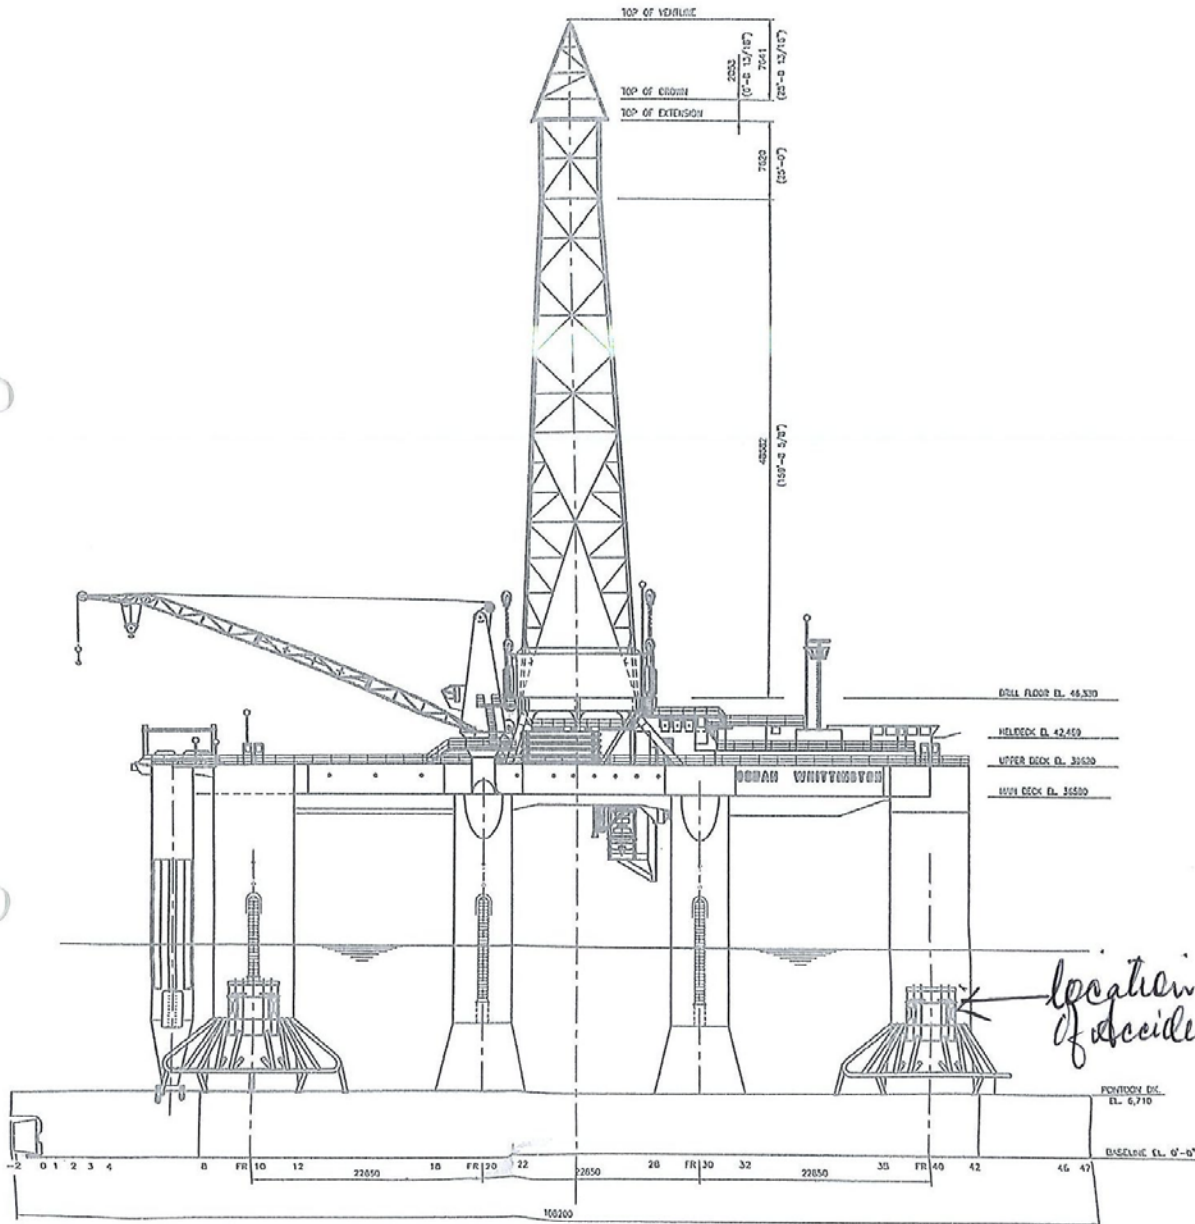
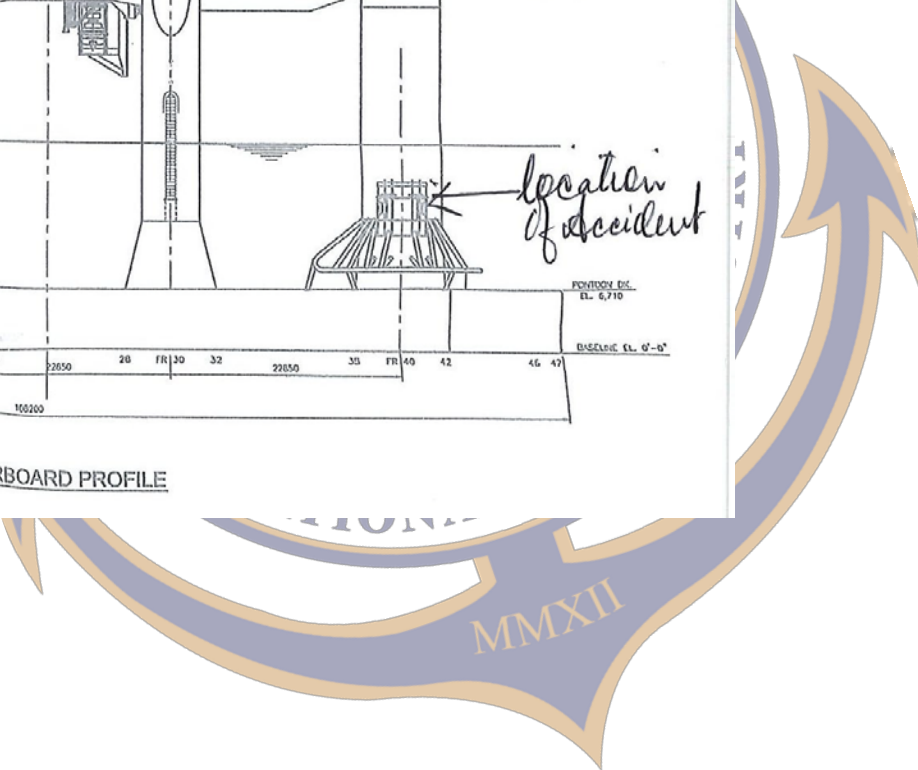
Location of Accident – Appendix 3

- 3.1. MODU unit's Master Captain Ravi organized the crew duties by 4hrs on and 4hrs off
- 3.2. On 1st Nov 2018, Electrician Officer Mr. Jose & AB MR. Gurmail Singh were on watch from 2000 hrs to 2400 hrs, While Jose went for changing the clothing, he informed Gurmail to wait him on deck, on his return Mr. Jose couldn't trace Mr. Gunnail Singh. After searching the rig, he found Mr. Gurmail Singh in an unconscious state inside the column. He came up and raised alarm. (**Location of Accident – Appendix 3**)
