MARINE INCIDENT SAFETY INVESTIGATION¹

Total Loss of Stability - Capsizing of Livestock carrier M/V “QUEEN HIND”

(PRELIMINARY REPORT)

Date: November 24th, 2019

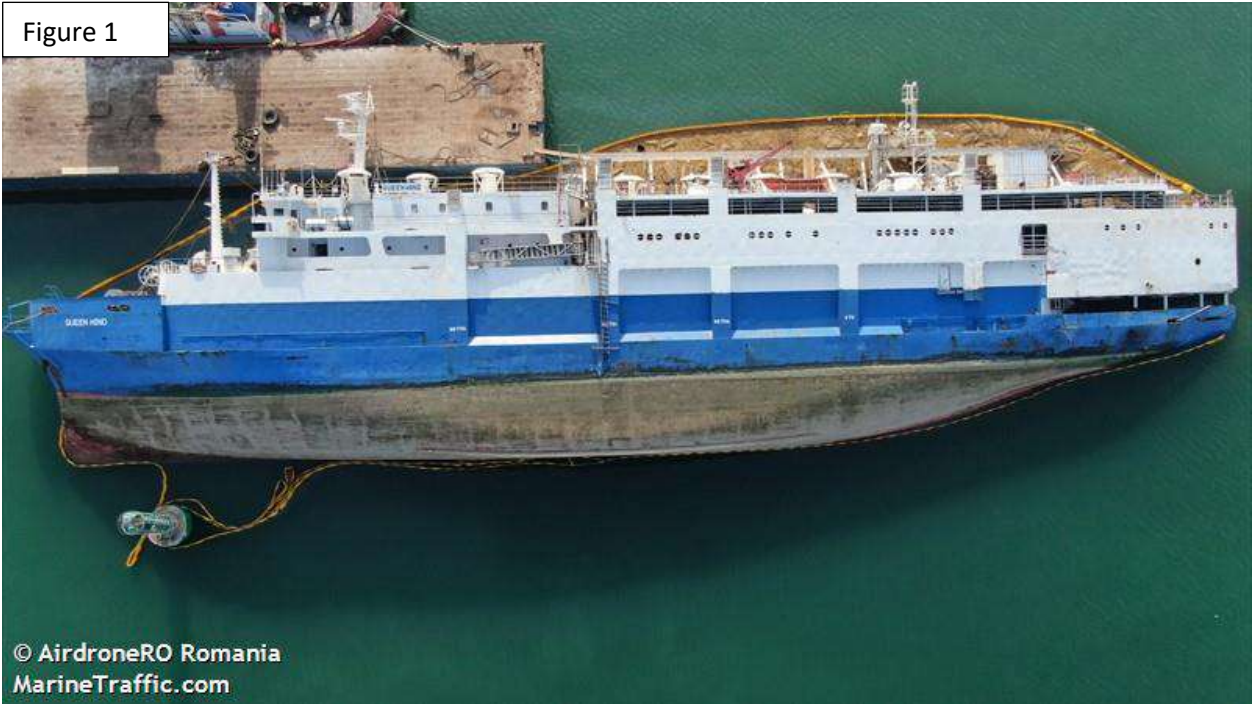
Figure 1

All crew have been rescued. One crew fall into water but was immediately recovered and transported by ambulance to the hospital where his condition was checked okay and released same day.

After recovering all crew, local authorities commenced searching and removing alive ovine, from the capsized vessel.

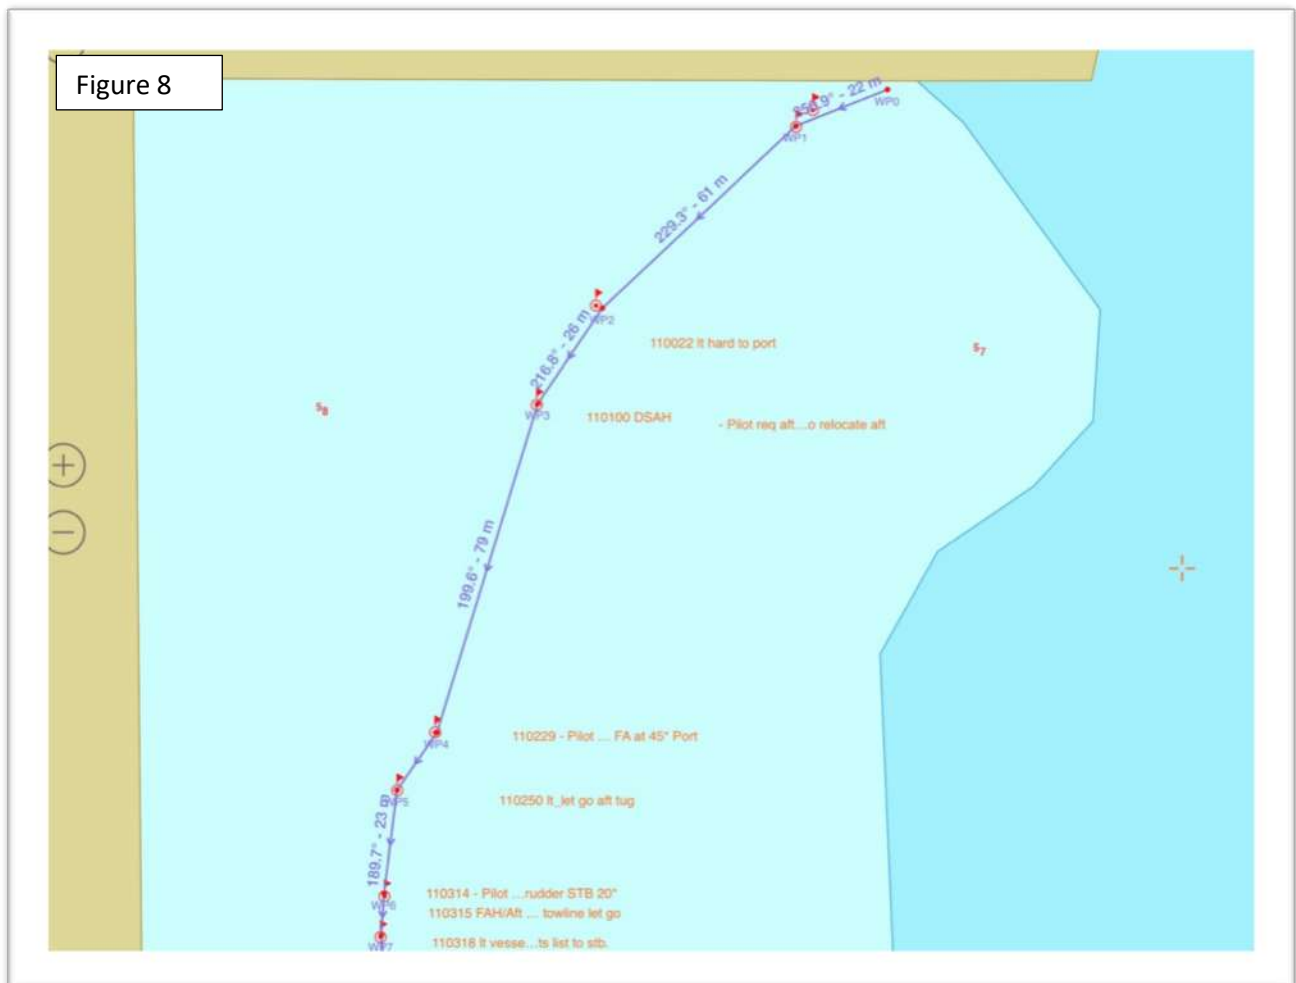
There was a brief discussion between Master and The Pilot and appropriate paperwork exchanged. Tugboats were made fast fore and aft at 1039 hrs, It and Pilot ordered to pull slow ahead. Both Master and Pilot have declared that the vessel's stern area did not move

and thus half ahead on tugs was ordered. Under tugs transversal action vessel heeled abt 5-10 degrees, as per Pilot statement. As vessel still not moving off the quay, Pilot ordered slow

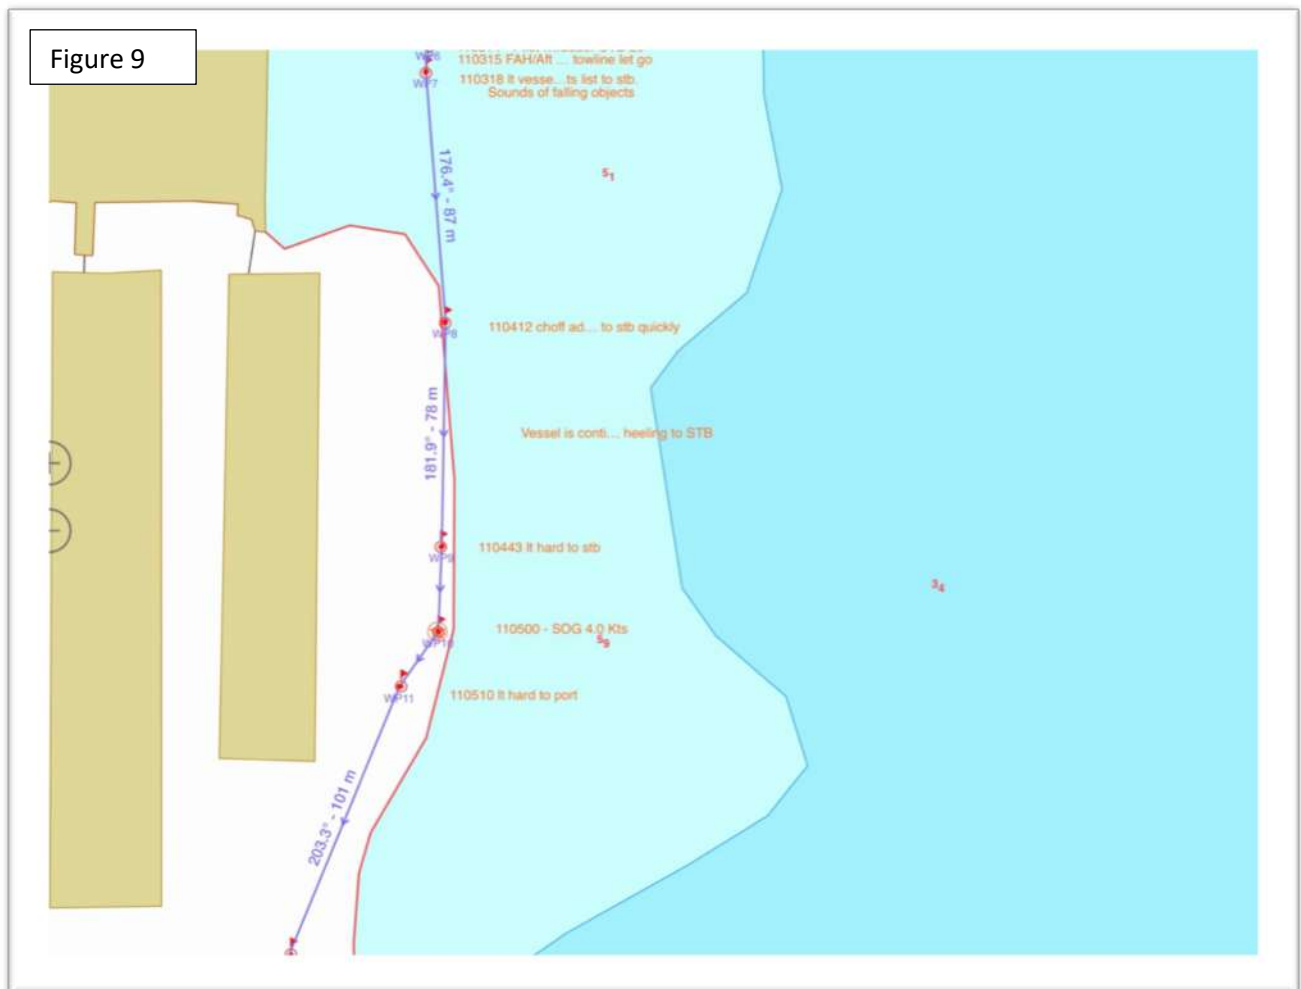
Soon after completion of port swinging maneuver under fore tug and rudder, while abeam with 2x1 Holding Shipyard, vessel started to list to starboard, for abt 5-10 degrees (WP5). Neither this time Master and/or the Pilot did not understand what is wrong with vessel's stability. Moreover, Pilot increased the main engine revolutions and consequent SOG and shortly, while passing Shipyard area vessel developed already abt 4.0 Kts and heeling to starboard is slightly but continuously increasing.

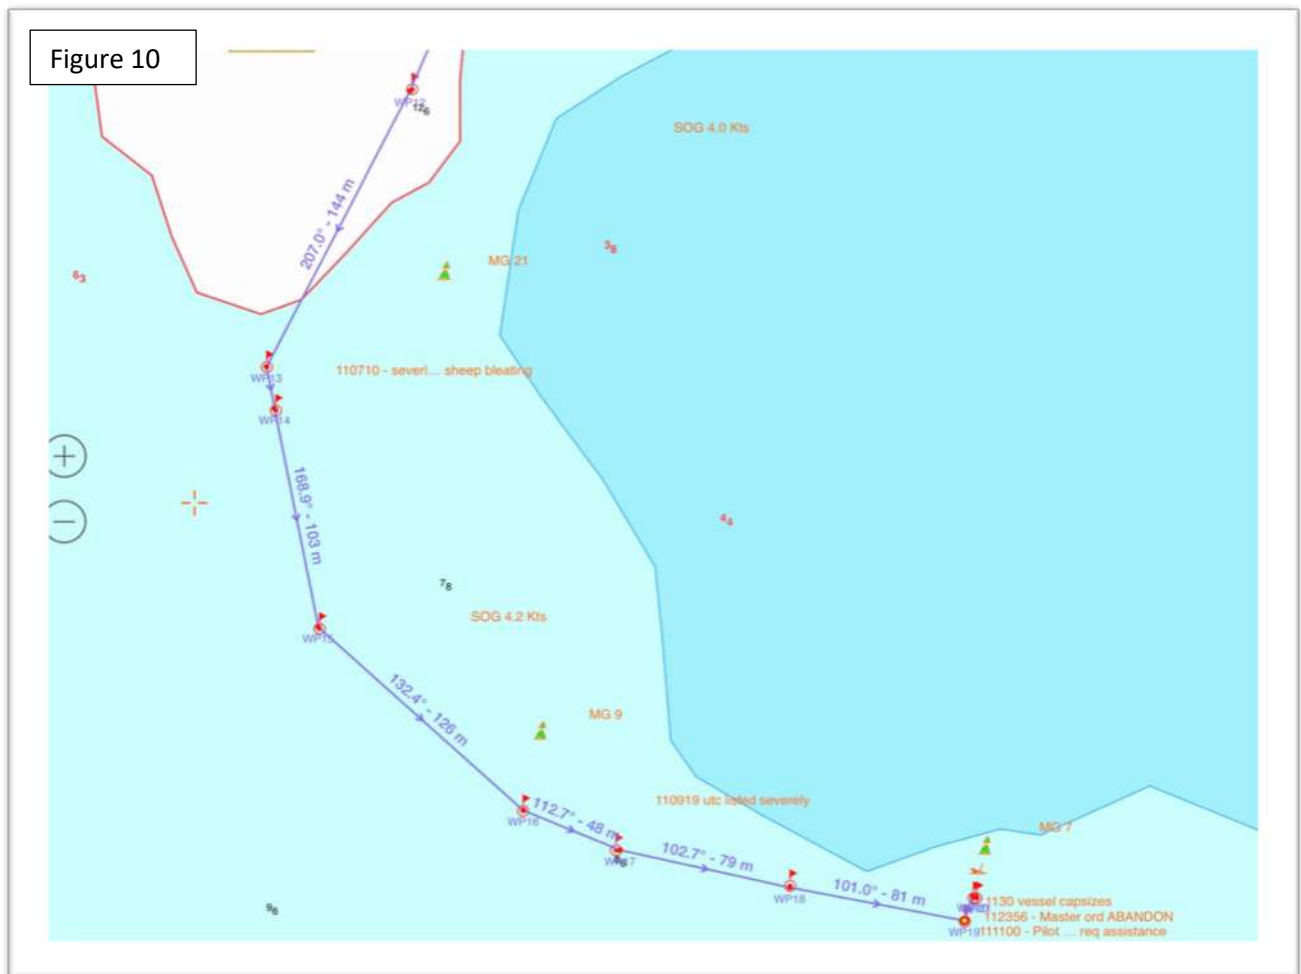
Aft tug is secured again, two more tugs arrived in assistance, but the vessel is severely heeled. Pilot ordered main engine stop and several astern commands are being noticed. Pilot struggles gives contradictory orders probably aiming to keep the vessel away from channel and also to prevent grounding. (WP17)

When the vessel reached several meters from MG7 it is already stopped and heeled abt 80 degrees. Pilot leaves the vessel by Aft tugboat and shortly, at around 1130 - 1140 hrs, It Master ordered Abandon Ship and all crew is evacuated by assisting tugs. Only one crew fall into water but is immediately recovered and send to hospital. All other are safe and sound being disembarked ashore (WP19).

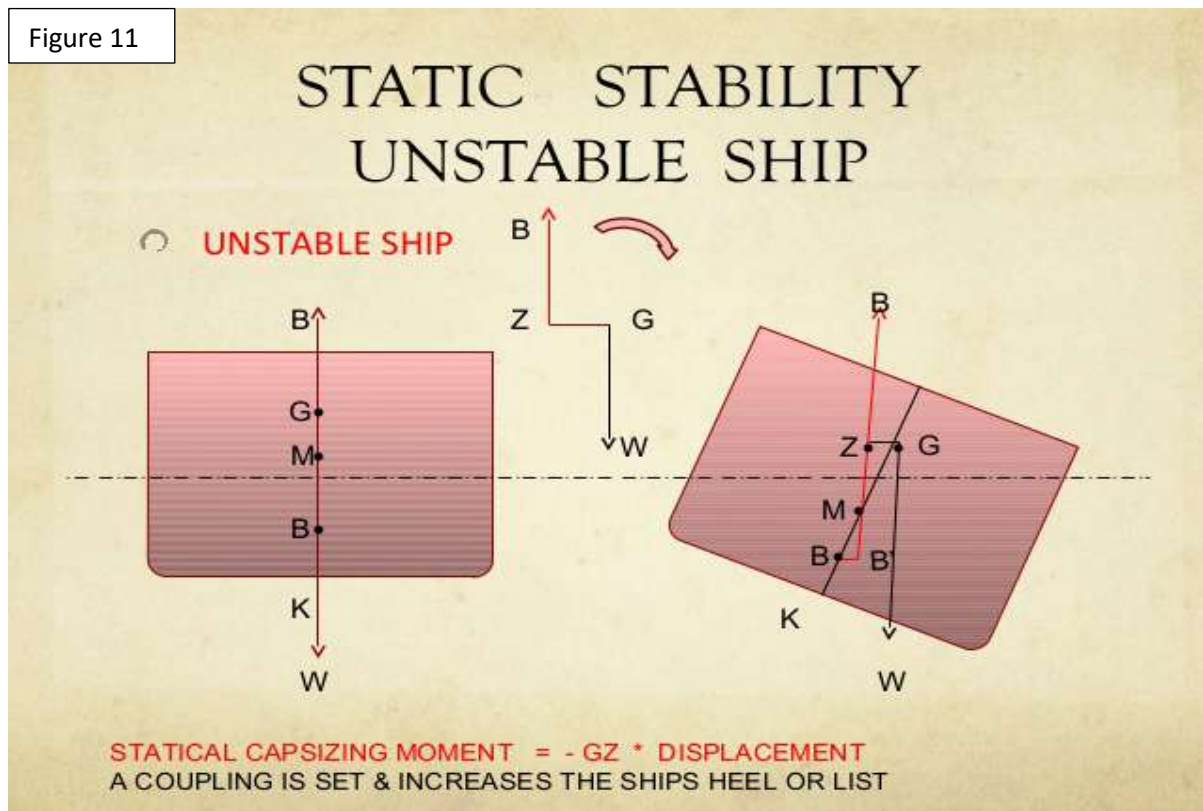
Figure 11

- 24) Master and/or Ch Mate failed to prove their understanding in respect with neutral versus negative stability. (ISM Code Ch. 6.2)
- 25) Master/Pilot increased the speed to 4.0 to 4.2 Kts after passing Drydocks area and in spite of moderate to severe list/heeling/lolling to starboard side, Pilot commenced turning maneuver at MG9 Starboard Green Buoy using the pulling effect to port of fore tug, hard over rudder to portside and high speed, facts that probably developed the negative stability uprighting moment which combined with heeling induced by the centrifugal force/rudder hard over and accentuated by the speed, increased the list/heeling triggering severe listing and shifting of cargo/weights on board to starboard side area and total loss of stability. Vessel was listed in this moment at an angle more than 40 degrees and continued to list.
