MARINE INCIDENT SAFETY INVESTIGATION¹

Total Loss of Stability - Capsizing of Livestock carrier M/V “QUEEN HIND”

(PRELIMINARY REPORT)

Date: November 24th, 2019

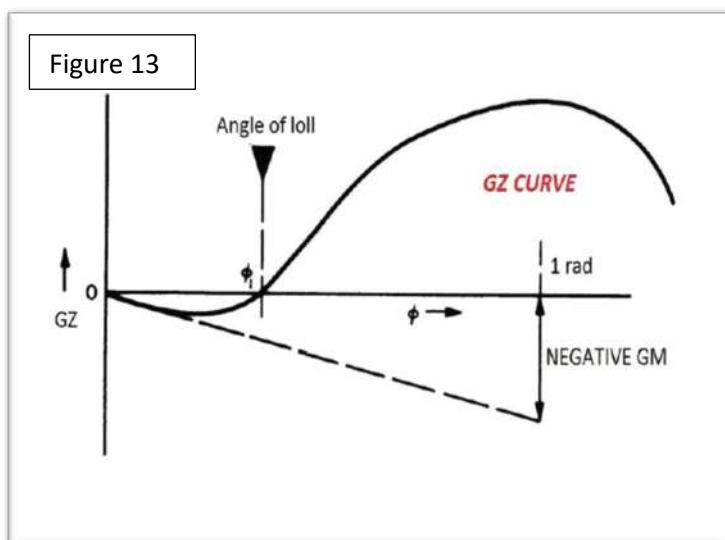
Furthermore, neither Master nor the Pilot managed to understand the behavior of a vessel with a negative stability, in an unstable equilibrium. Several heelings, first to Port (under the action of towing lines) and then to Starboard side, under the combined effect of rudder, tow and consequent centrifugal force, amplified by a speed of more than 4.0 Kts, were inside the LOLL angle fact that developed a negative righting moment which combined with heeling, animal and big bags shifting to starboard, leded to a total loss of stability and capsizing.
